# *Comprehensive Home Inspections, LLC*

## Property Inspection Report

123 Main St, Anytown NJ, 11111  
Inspection prepared for: John Smith  
Inspection Date: 8/21/2011

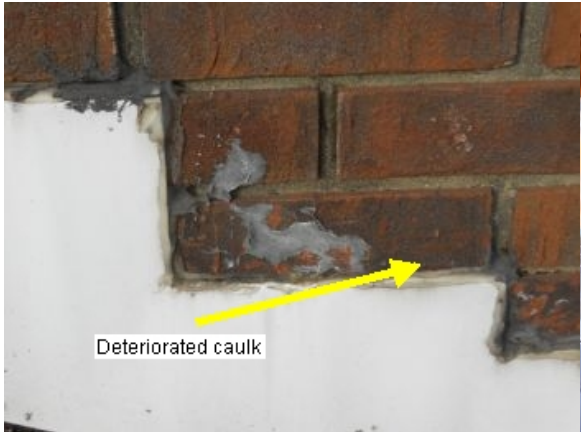
- IMPROVE: The caulk/tar at the chimney flashing is cracked and seperated. This can lead to water penetration inside the house. I recommend properly sealing the flashing to the chimney to prevent water penetration and damage.

Deteriorated caulk

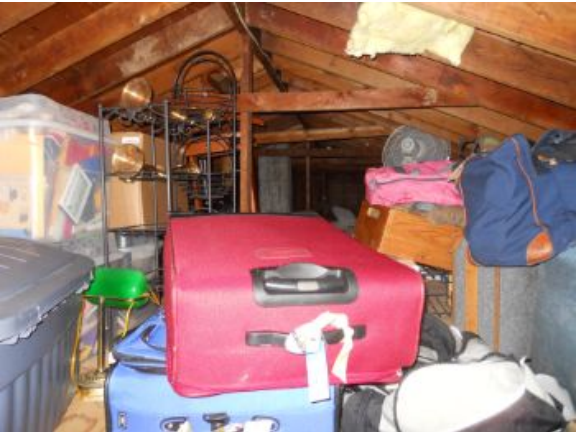
Cluttered attic

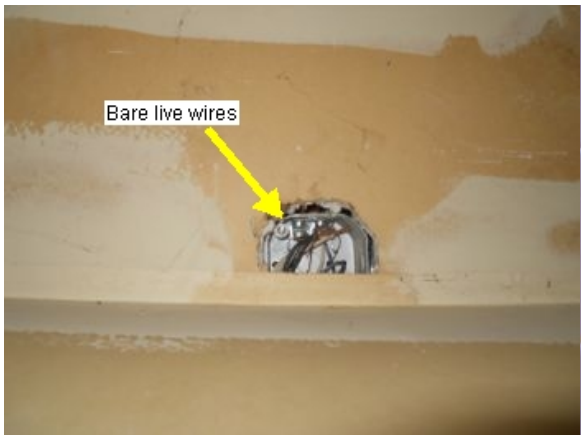
- **SAFETY ISSUE:** One outlet in the small bedroom is loose, pulling off the wall when a plug is removed. This can potentially cause a shock hazard. I recommend this be repaired by a qualified individual.
- **SAFETY ISSUE:** There is an open junction box above the water heater. There are live, unprotected wires inside, causing the possibility of electric shock. I recommend capping the wires and installing a cover to prevent injury.

Bare live wires

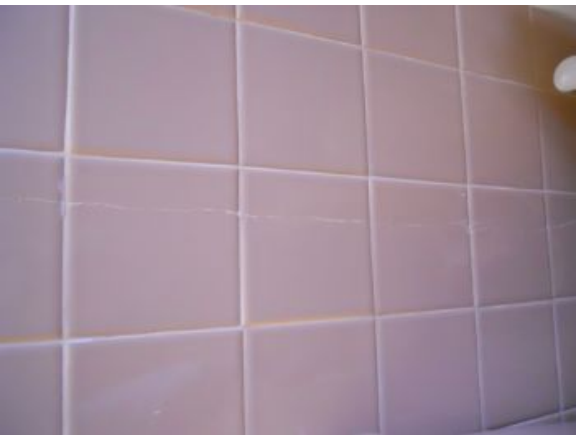
- **IMPROVE:** Some of the tiles in the bathtub enclosure have missing or deteriorating grout. I recommend regrouting and caulking the tub enclosure as needed to prevent leakage.
- **MONITOR:** Although there was no visible evidence of leakage at the time of the inspection, the ceiling below the toilet in the 2nd floor bathroom shows evidence of prior leakage. The ceiling was dry at the time of the inspection.

Cracked wall tiles in the bathtub

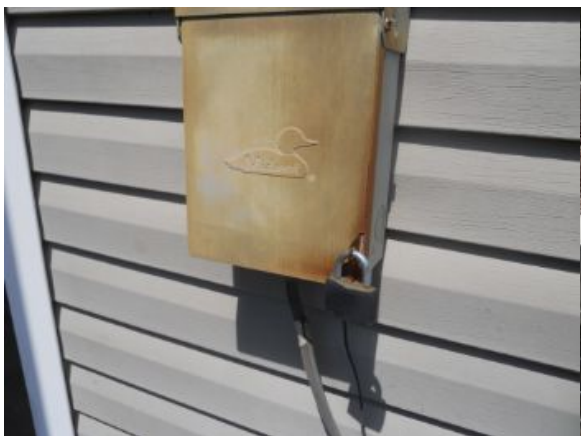
- There was a lock on the disconnect switch next to the outside unit. The switch could not be inspected.
- Determining cooling supply adequacy or distribution balances are difficult to determine and are not part of this inspection.

Locked disconnect switch

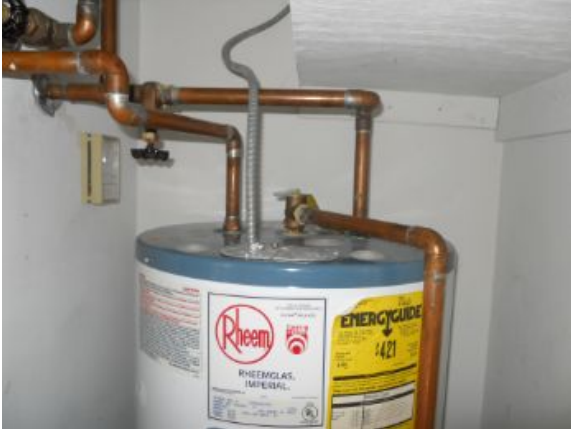
- **SAFETY ISSUE:** The water heater is not bonded, causing the possibility of electric shock. I recommend having a qualified individual properly bond the water heater.

- **SAFETY ISSUE:** The water heater is not bonded. Bonding can prevent electrical shock. I recommend adding a bonding wire.

Unbonded water heater

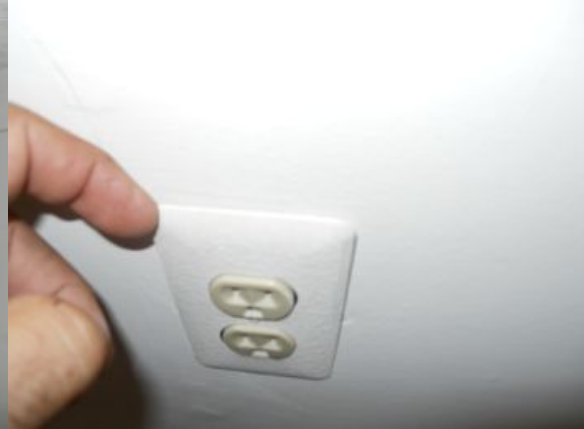
Loose outlet

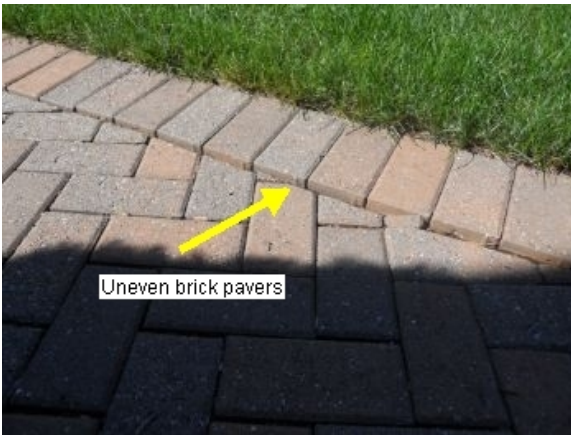
- **SAFETY:** Portions of the brick walkway have settled, causing an uneven surface. This is a potential trip hazard. I recommend having a qualified individual make necessary repairs to insure an even surface.

Uneven brick pavers

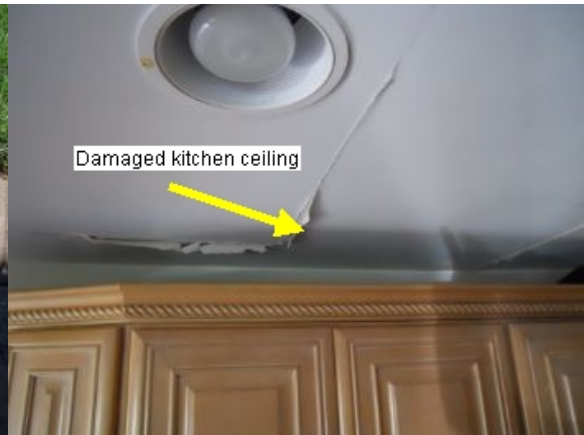
- The ceiling in the kitchen shows evidence of prior leakage. See the plumbing section for further info.

Damaged kitchen ceiling
